Final Report FR 6002

Analytical, Experimental & Developmental Work

Radiative Heating System

Volume II of III

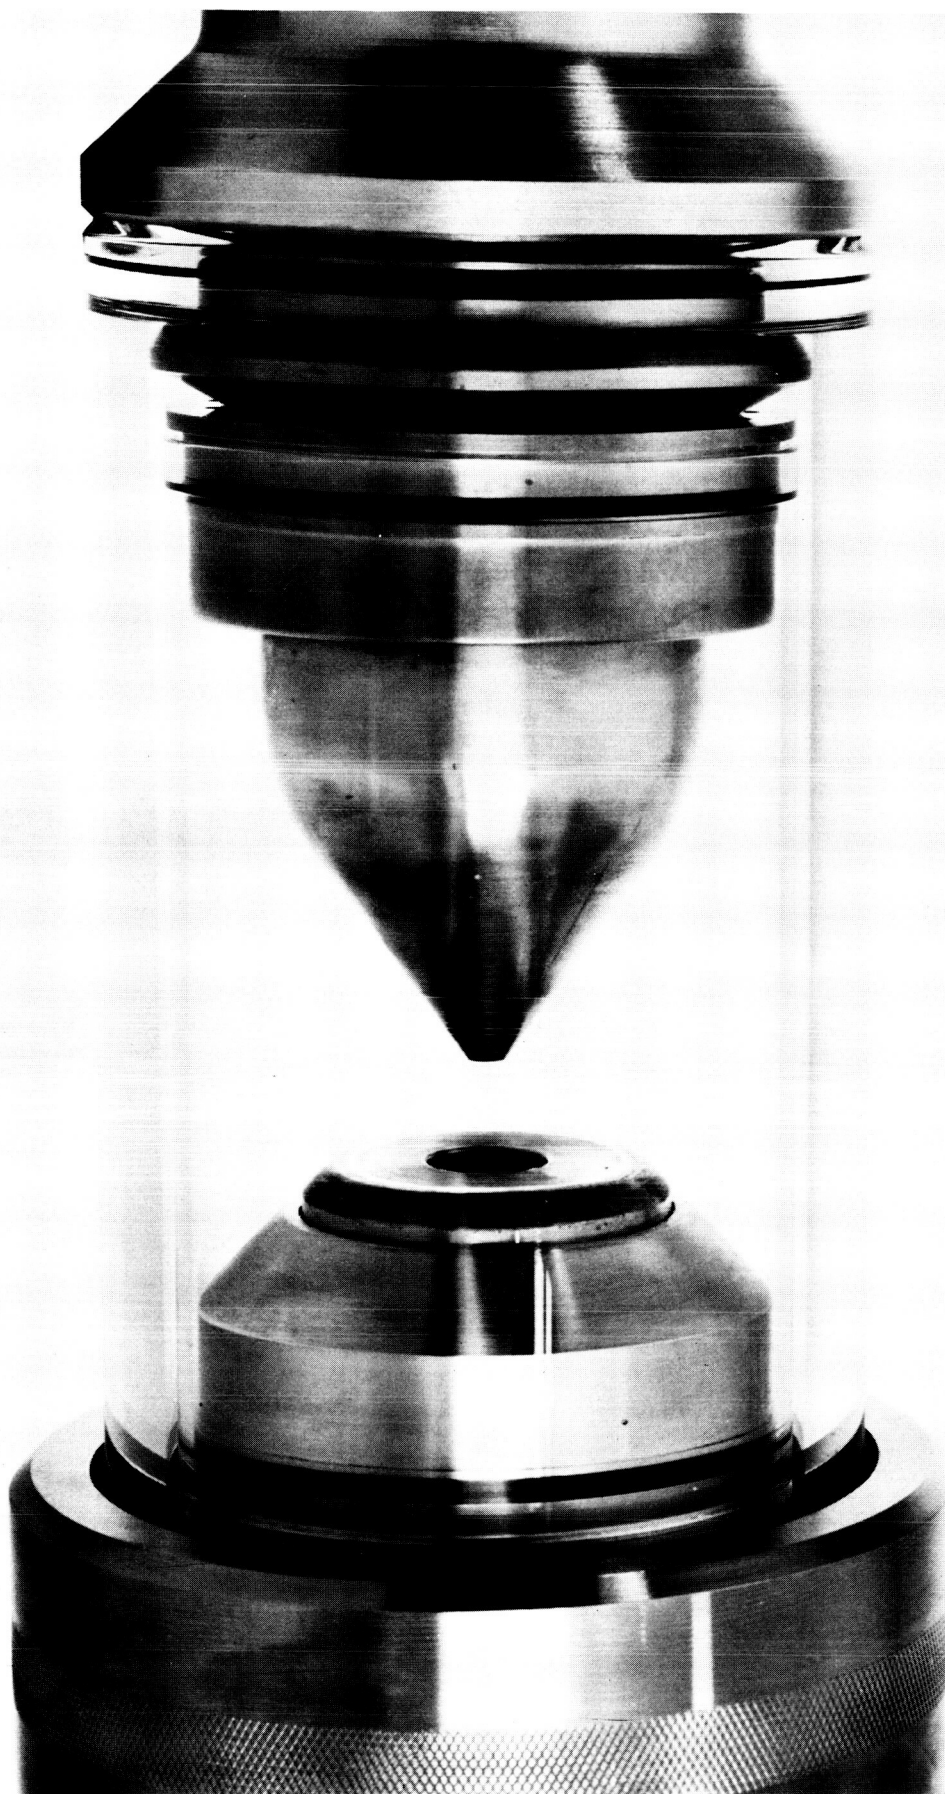
Figure 4 - Closeup of Arc Area in Final Radiation Source

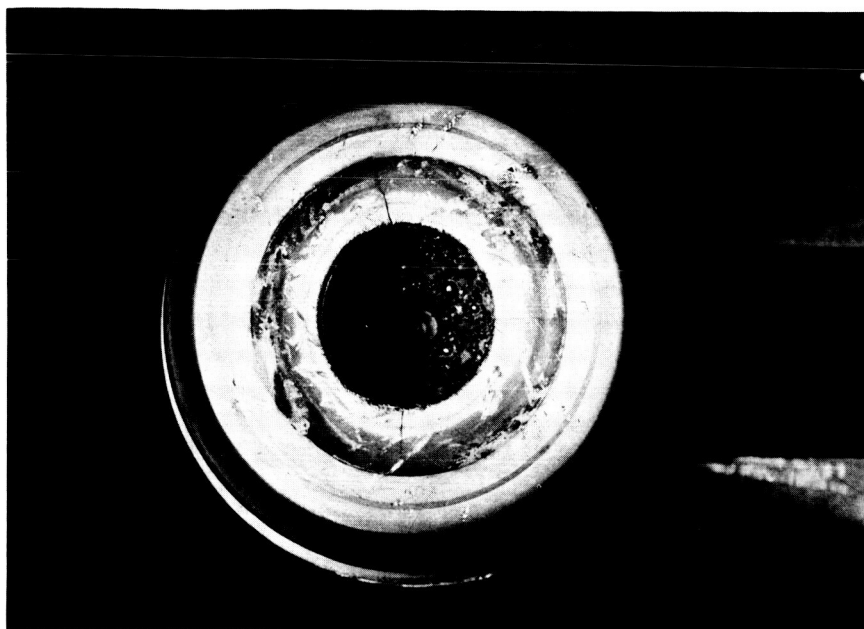
Anode Exhibiting Radial Cracks in Molybdenum Diffuser

Figure 1 - Condition of Anode and Inner Quartz Envelope After Completion of Test Run 13

The cause of the crack in the molybdenum diffuser is not evident at this time since this condition has not been observed in any of the previous test runs using the molybdenum diffuser. The ablation of the cathode does not appear to be related to the current level at which the cathode is operated since ablation occurs at current levels of 1,000 and 1,400 amps. However, there is some difference in the mode of ablation since the protrusion on the cathode tip appears

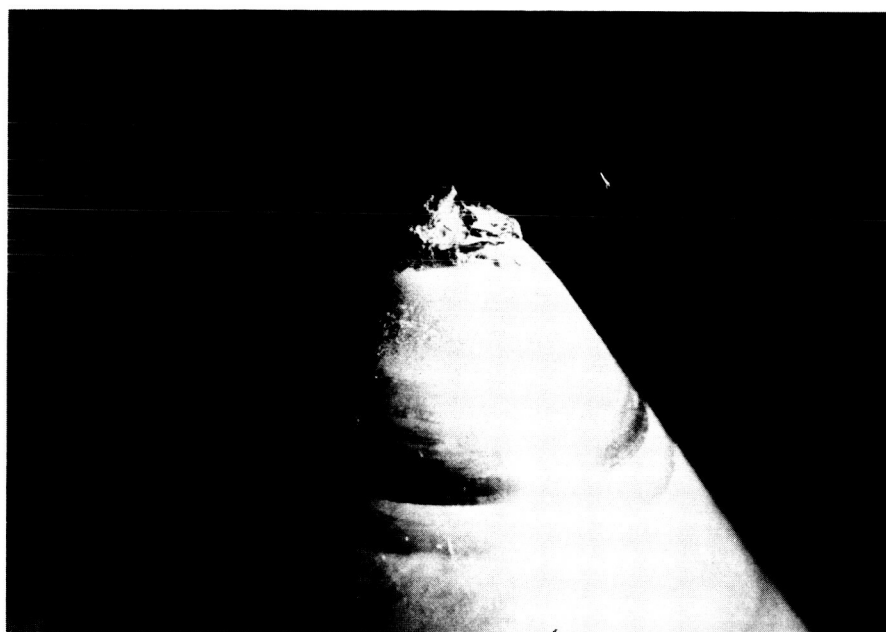
Figure 2 - Cathode After Completion of Test Run 13

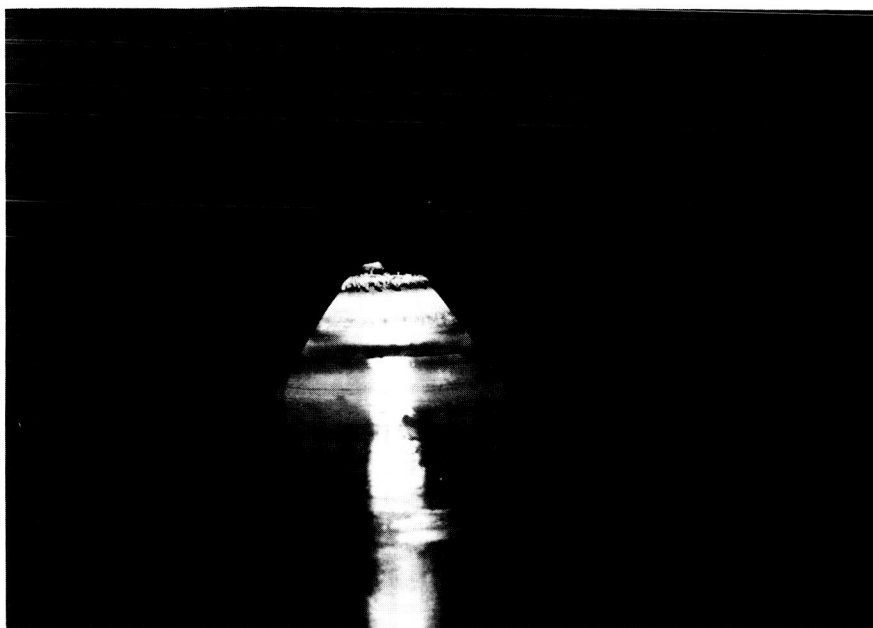
Figure 3 - Condition of the Cathode After Completion of Test Run 19

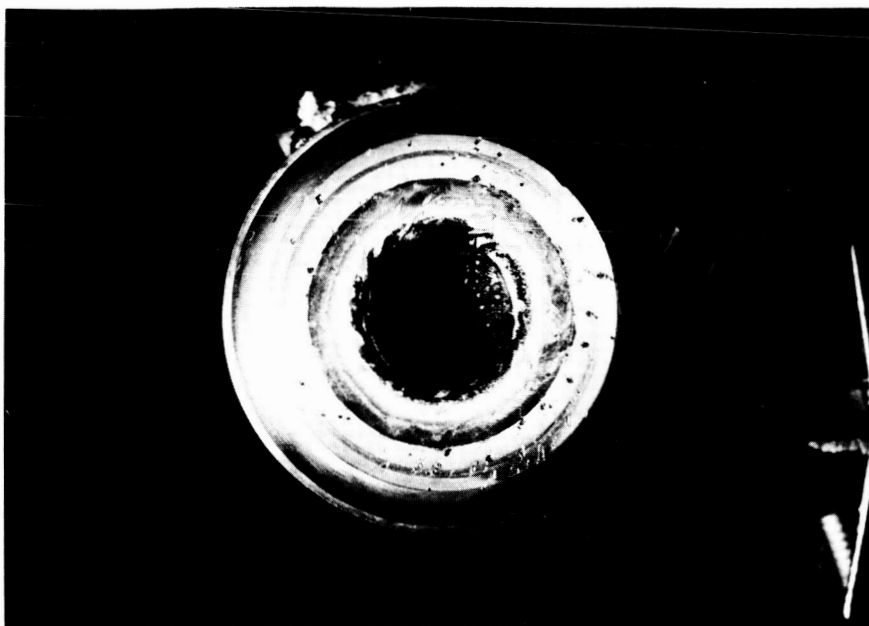
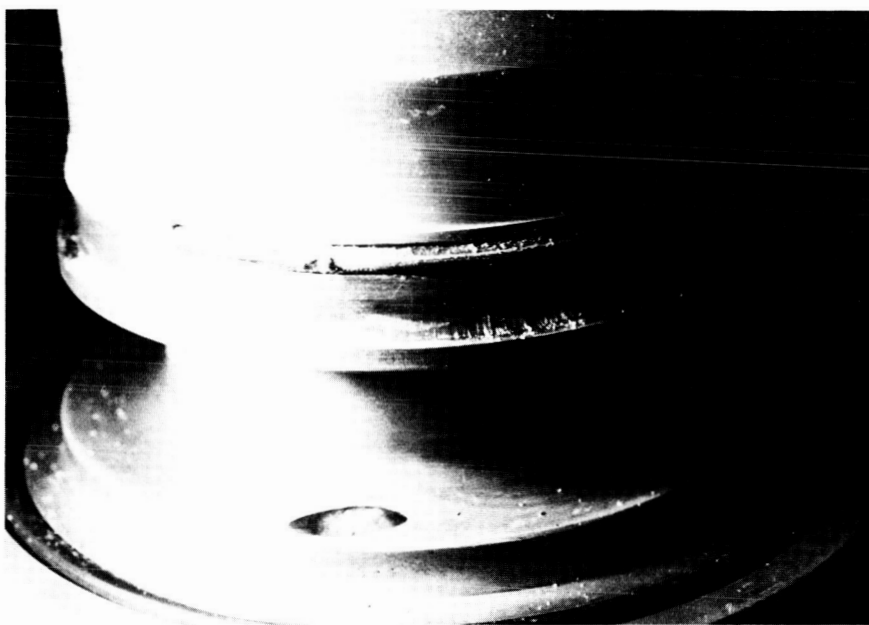
Anode After Test Run 19

Anode Clamp Ring Showing Tungsten Particles Resting on O-Ring

Figure 4 - Condition of the Anode and Anode Clamp Ring After Completion of Test Run 19

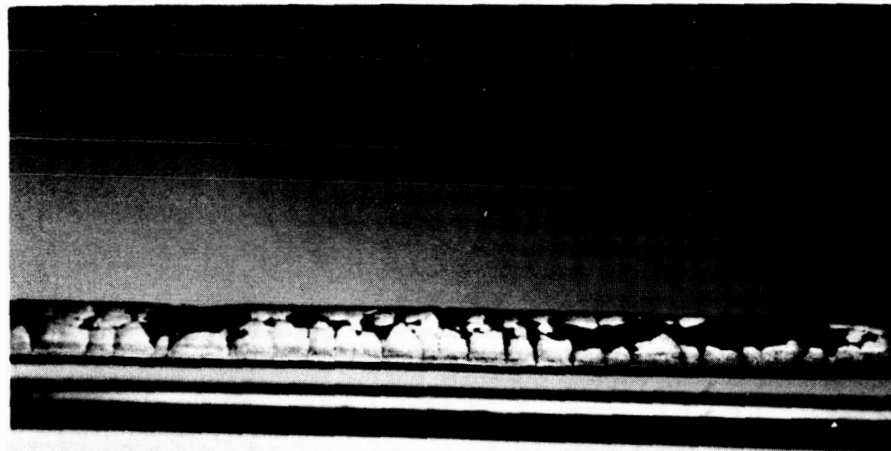
Figure 2 - Degradation of O-Ring Seal on Inner Quartz Envelope

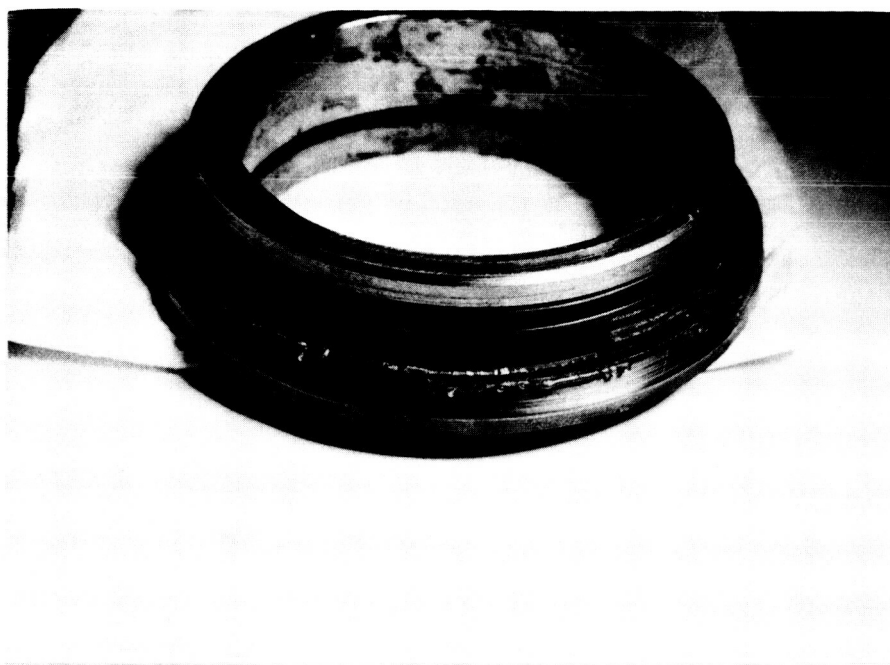
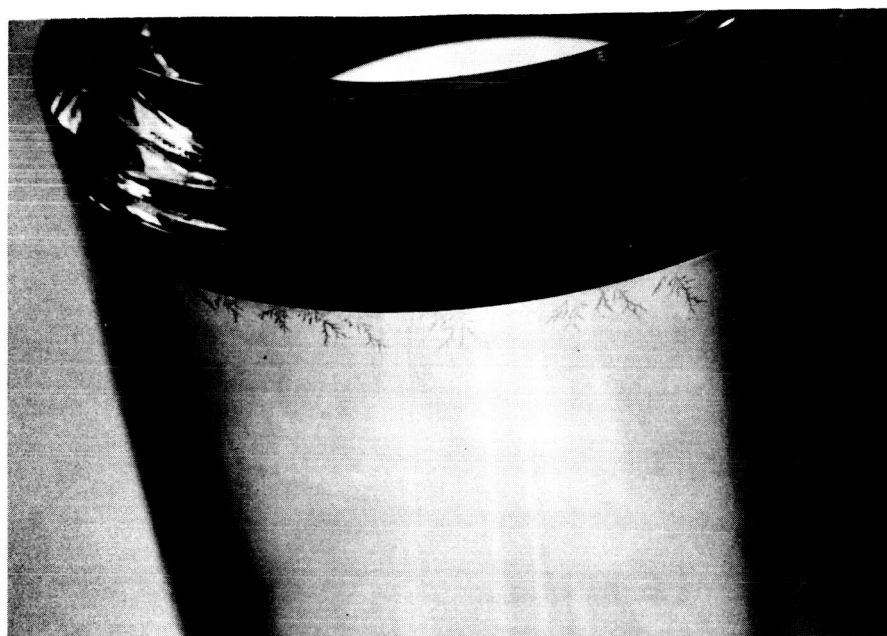
Figure 3 - Degradation of Kel-F Gaskets After Test Run 39

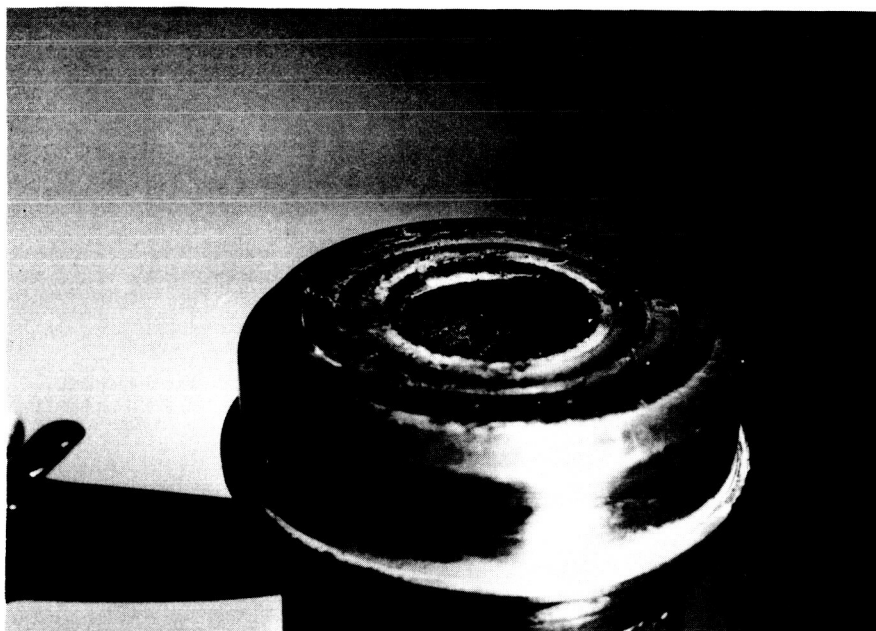
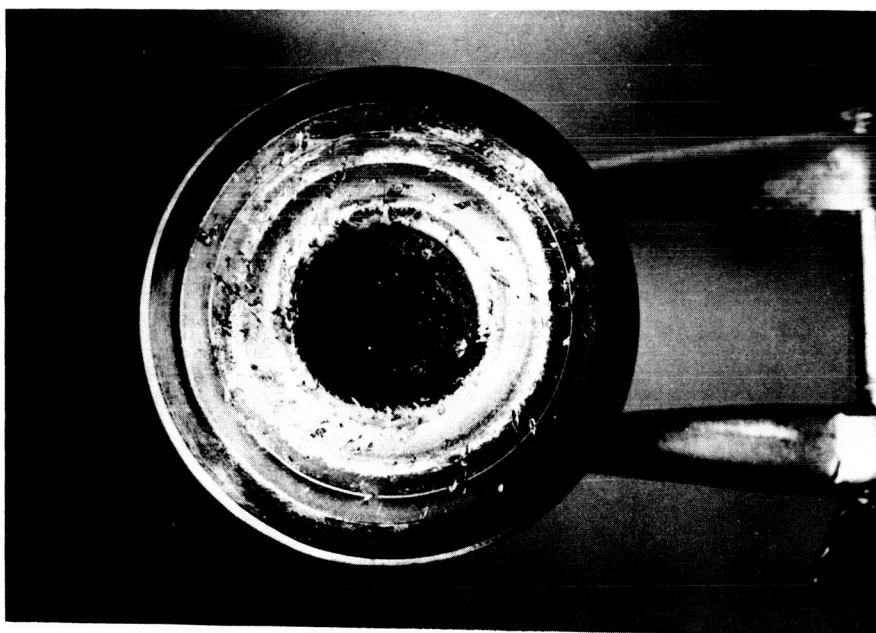
Figure 5 - Condition of the Anode After Test Run 39

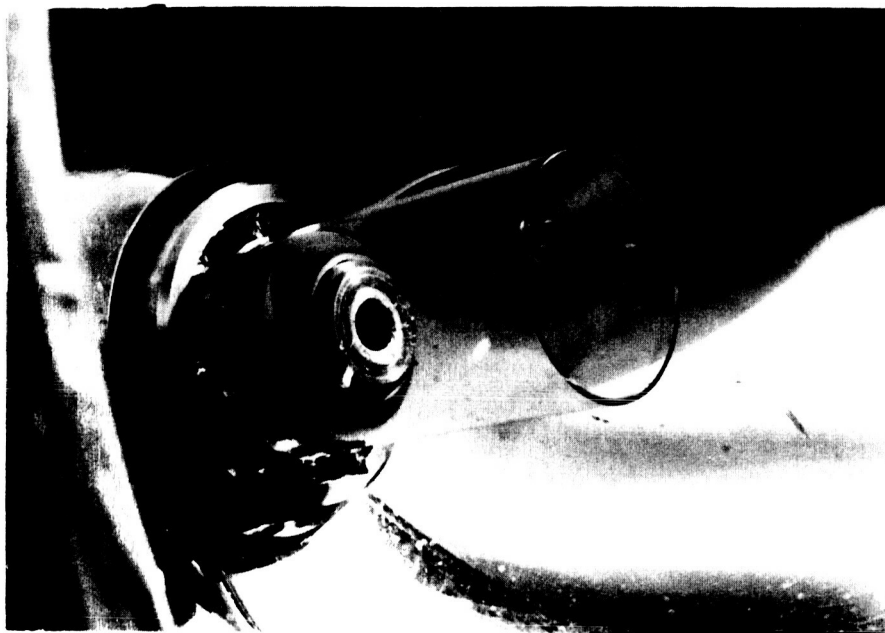
Figure 1 - Radiation Source Parts Remaining in Collector After  
Failure of Outer Envelope

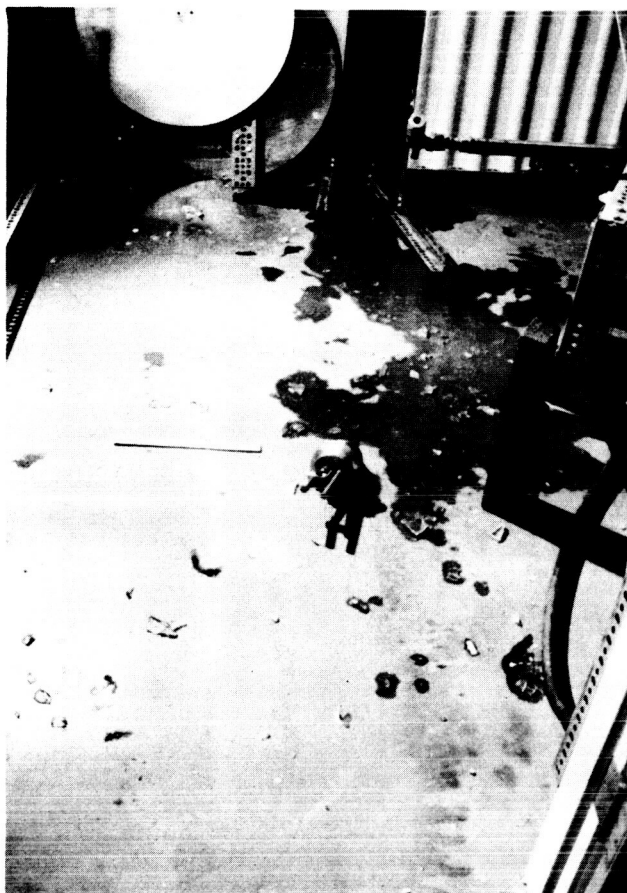
Figure 2 - Location of Cathode Assembly and Quartz Fragments  
in Test Site after Outer Envelope Failure
